Stormwater Mapbook Index - Conditions
Tisbury, MA
 January 2018

Stormwater Mapbook - Conditions
Tisbury, MA
January 2018

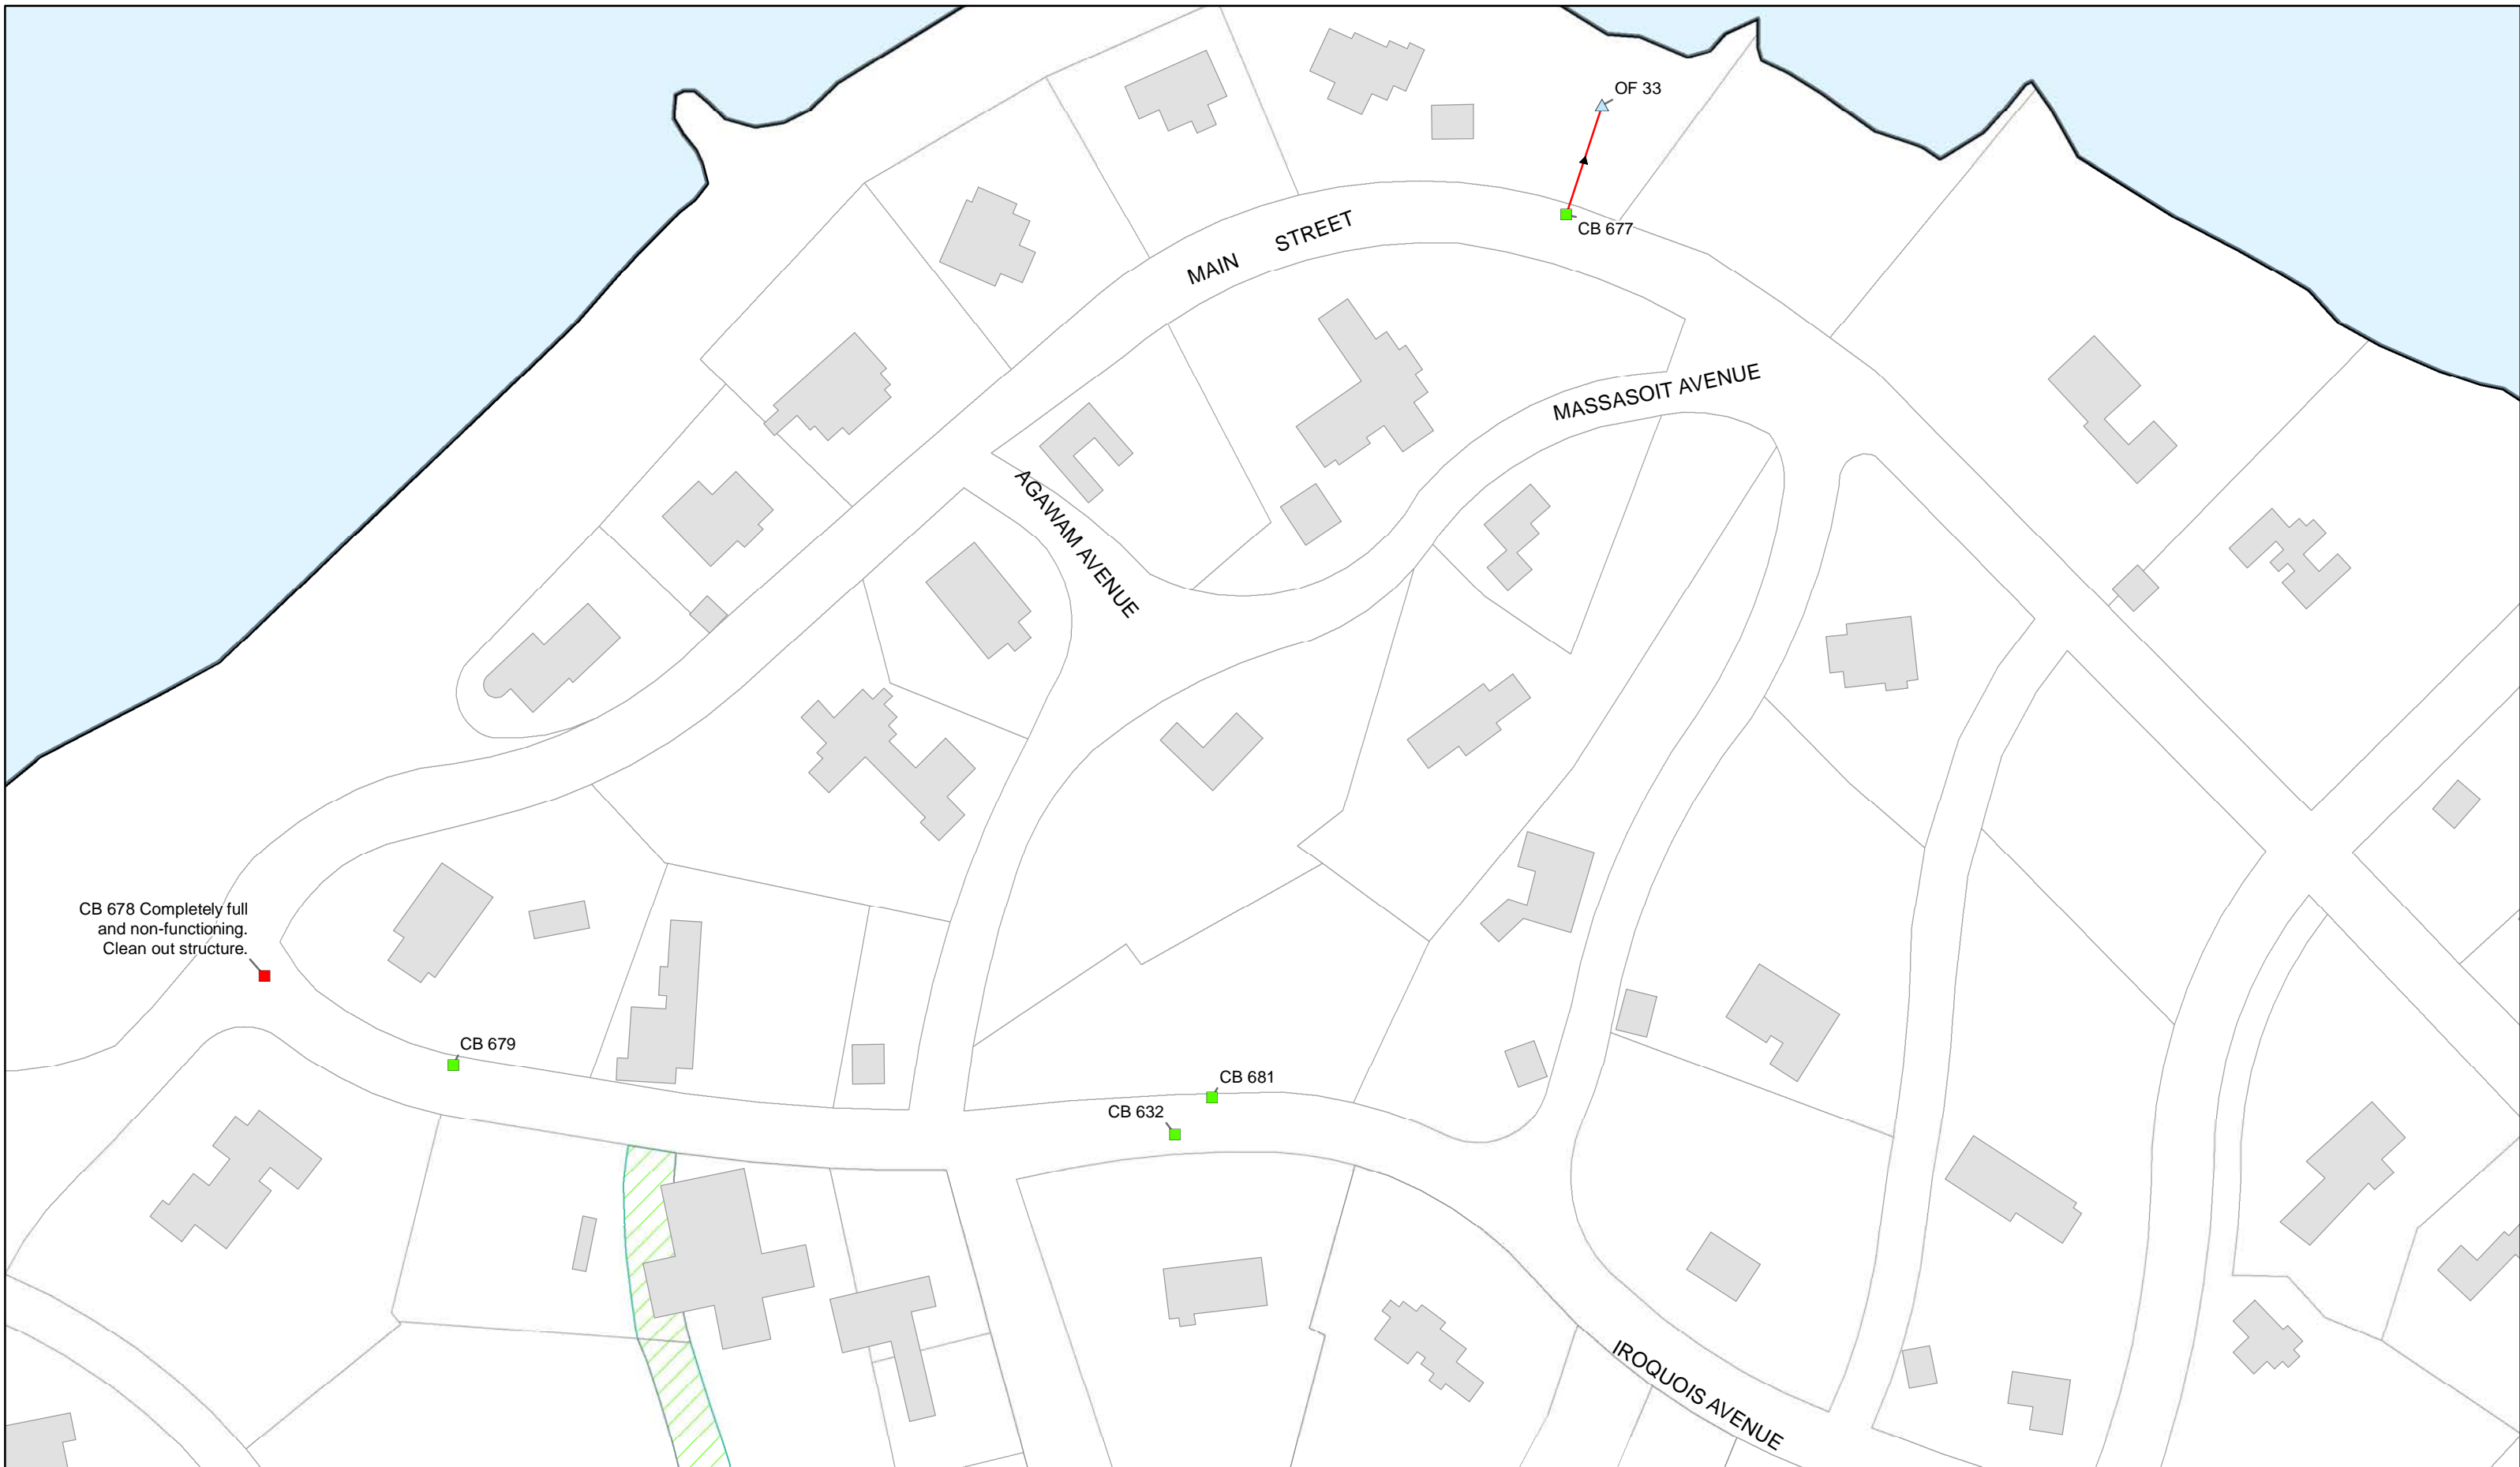
CB 678 Completely full and non-functioning. Clean out structure.
