# Navigating Challenges and Solutions: South Coast AQMD Experience with Met One BAM 1020 3rd Generation Monitors

2024 NAAMC  
August 12-15, 2024

Juan Garcia  
Monitoring Operations Manager  
South Coast AQMD  
JGarcia@aqmd.gov

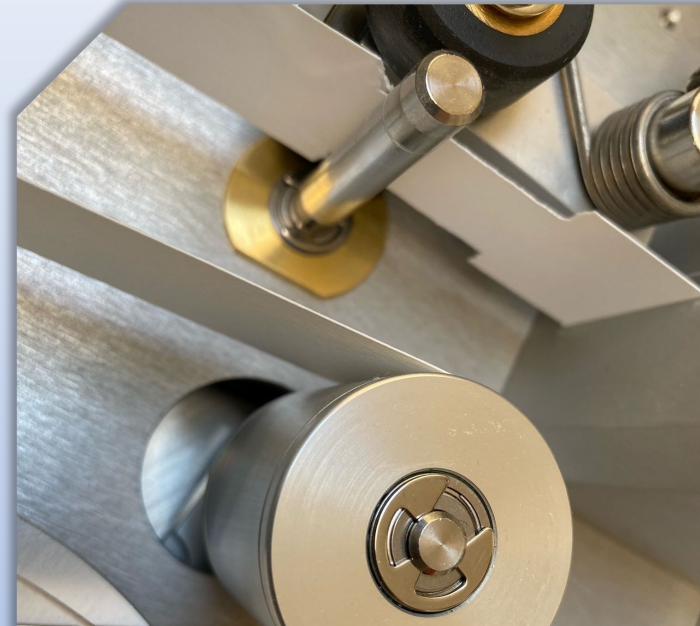
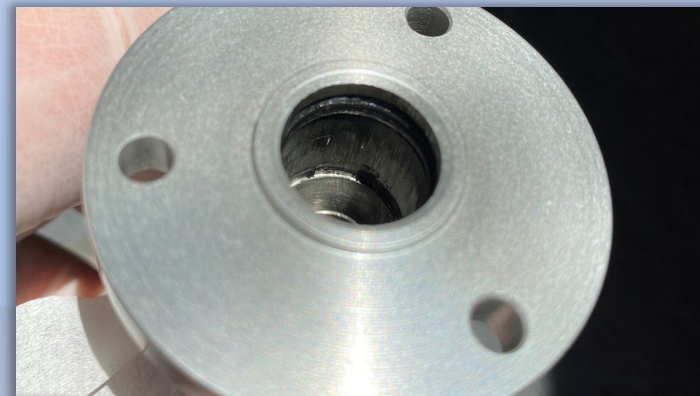
- Build Quality
  - Improperly assembled take-up reel, resulting in tape misalignment
  - New pinch rollers accumulate tape debris quickly and need frequent cleaning
- Hardware
  - Power supply
  - Grounding issues
    - Paint on internal ground connection
- Firmware
  - Ethernet dropouts caused the BAM to fail in responding to further requests.
- Zero Test
  - Zero test impacted by a high background and standard deviation values during field deployment

- Communicated directly with Met One engineers regarding issues
- All South Coast AQMD 1020 Gen 3 units were returned to Met One for upgrades and inspections
- Upgrades done at Met One:
  - Removed paint at chassis ground points
  - Replaced ball slide bearings
  - Firmware updates
- Field upgrade recommended by Met One:
  - Relocate ground wire from the pump to earth ground on wall outlet
  - Minimize temperature swings during zero test

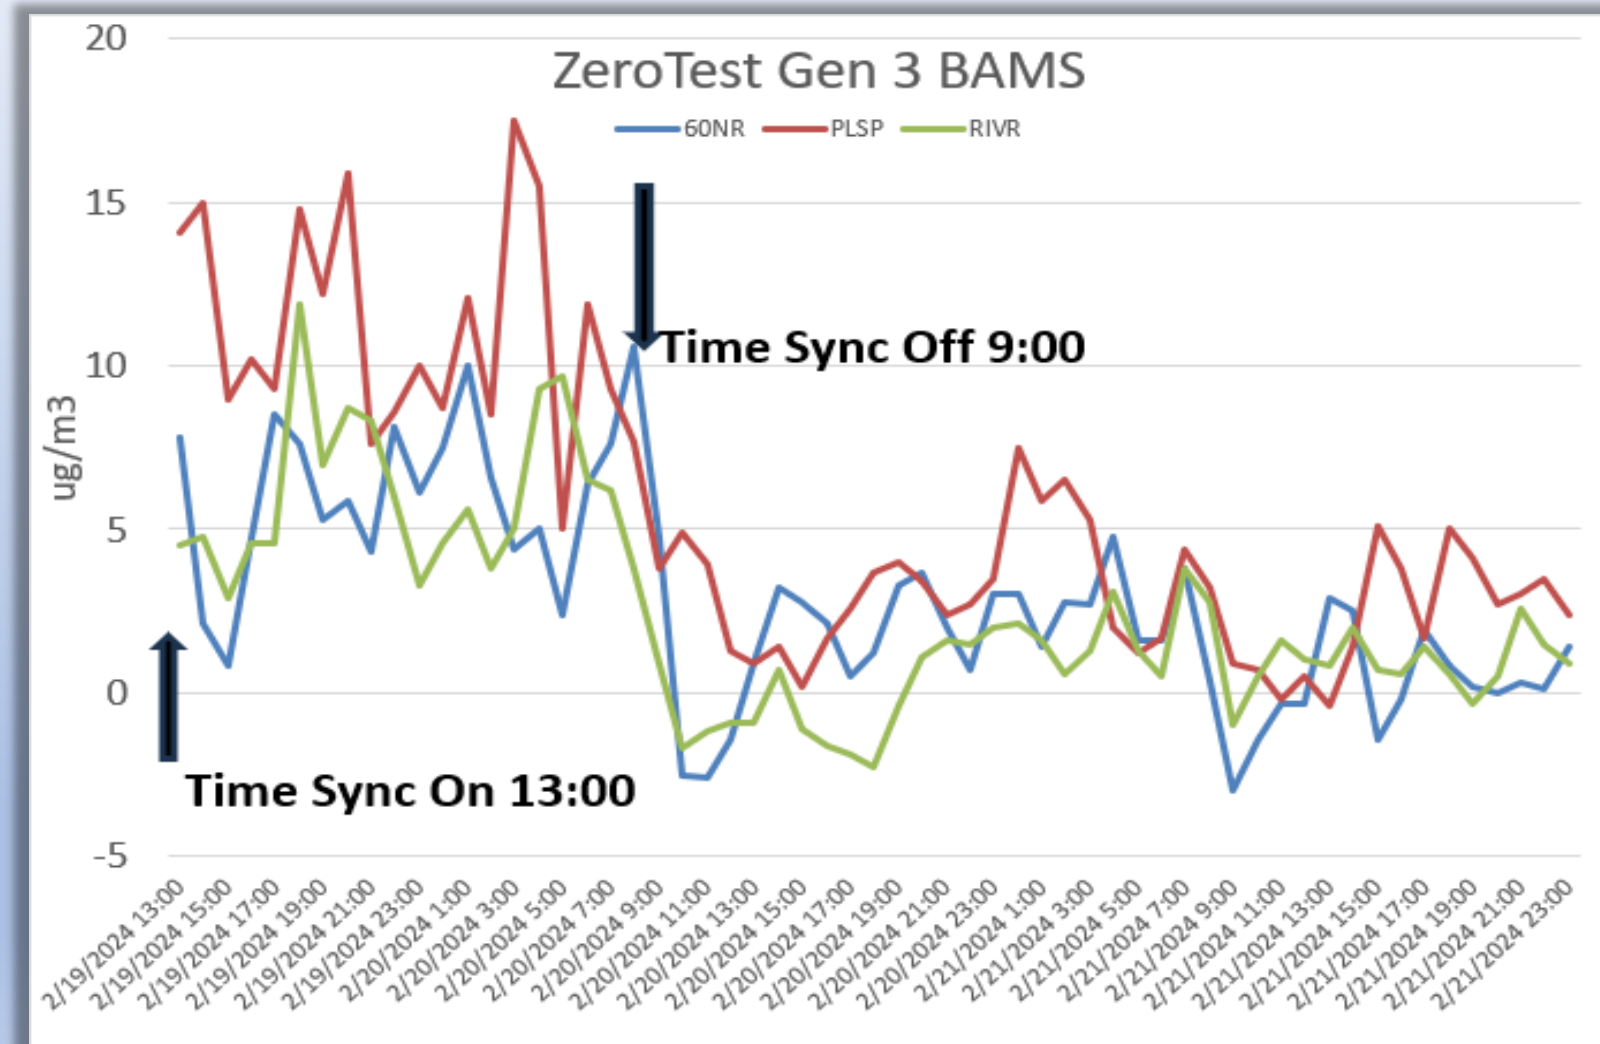
- The primary cause of increased background noise was due to time sync issues
- These issues could cause the background levels to increase by 4-8 ug/m<sup>3</sup>

- Adjust the time sync to occur in the middle of the hour
